2019–2020 NTSB

MOST WANTED LIST OF TRANSPORTATION SAFETY IMPROVEMENTS

Strengthen Occupant Protection

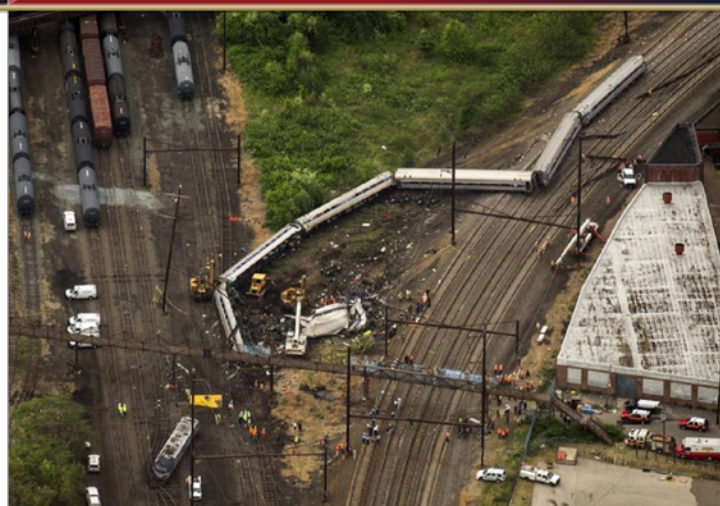
On May 12, 2015, eastbound Amtrak passenger train 188 derailed in Philadelphia, Pennsylvania, with 245 passengers and 8 Amtrak employees on board. The train had entered a curve—where the speed is restricted to 50 mph—at 106 mph. Eight passengers died and 185 others were injured. We found that if the passenger car windows had remained intact and secured, some passengers would not have been ejected and would likely have survived. Further, many passengers were seriously injured after being thrown from their seats when the cars overturned. Investigators, seen below at the scene of the accident, concluded that the current passenger equipment safety standards were inadequate.

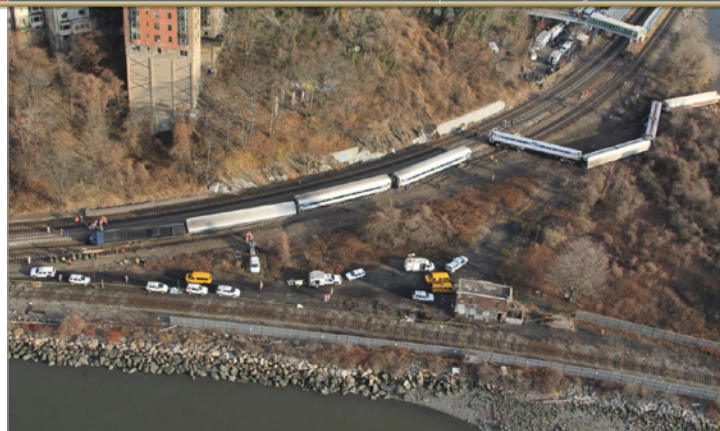
On December 1, 2013, southbound Metro-North Railroad passenger train 8808, en route to Grand Central Station in New York City, derailed on main track 2 of the Metro-North Hudson Line. Four people died and at least 61 were injured. Contributing to the severity of the accident was the loss of the window glazing that resulted in the fatal ejection of four passengers from the train.

- › Adopt existing voluntary standards that address crashworthiness and strengthen occupant protection for train passengers and crews. Protecting passengers and crews from injury requires keeping railcar windows intact and maintaining their structural integrity during an accident, and includes occupant restraint systems, such as seat belts, to mitigate the severity of passenger injuries. Incorporate design elements that optimize crashworthiness and enhance ease of evacuation in an emergency.
